ONEIDA NATION OF NEW YORK TRIP REPORT

Assessment of Mold and Moisture Conditions

January 21, 2003

U.S. Department of Housing & Urban Development
Office of Native American Programs

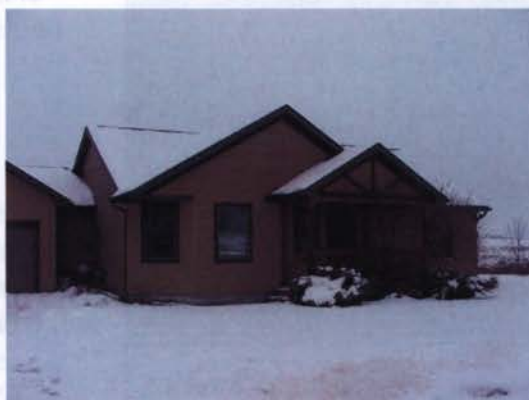
Figure 1 - Typical home in the Oneida development

The five inspected homes are part of a twenty home development built in 1994. The homes are located on the adjoining streets of Sweetgrass Lane and Runner's Road. The homes are of similar design and construction (Figure 1). Although the homes are of modular construction, they have interesting spaces and rooflines.

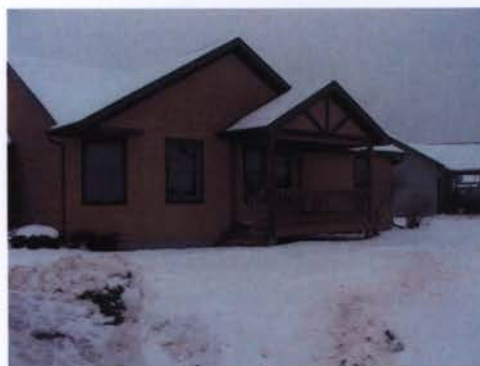
Figure 1 2211 Sweetgrass

Mold and Moisture Conditions: Site drainage was quite poor. The home was located at the base of a small hill (Figure 2). Localized dips and holes were found adjacent to the foundation. Mold was reported on the bathroom ceiling. The house was vacant and interior remediation efforts were underway.

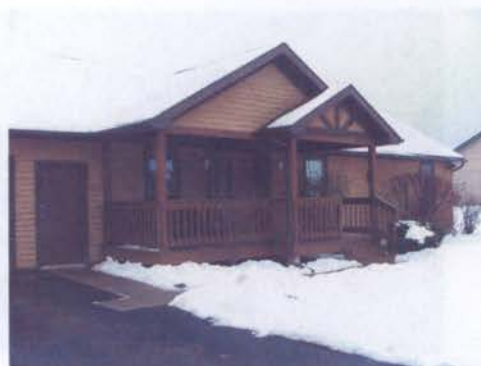
Figure 1 - 3303 Runner's Road

Mold and Moisture Conditions: Site drainage was flat, especially under the rear deck. Gutter system was in good condition. Basement walls were reinforced because of buckling. Basement walls were wet (Figures 2 & 3) and standing water was found on the basement floor.

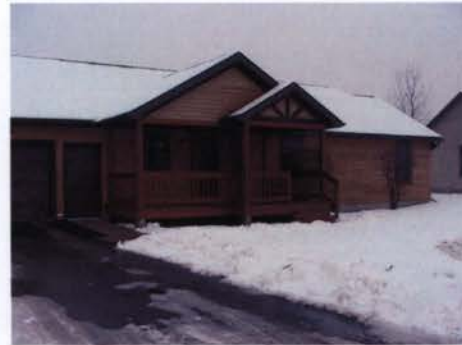
**Figure 1 – 3302 Runner's Road**

Mold and Moisture Conditions: Site drainage was flat. The rear gutters were full of snow. Water dripping from the gutters was splashing on the siding (Figure 2). Some leaders were missing. Mold was visible on the basement walls (Figure 3). The house had an attached crawl space open to the basement. A ground cover was present, the duct was insulated, foundation walls were not insulated and the vents were sealed. There was a fair amount of clutter in the crawl space.
